USAAMRDL TECHNICAL REPORT 72-31

AIRCRAFT CLUTCH ASSEMBLIES, RAMP ROLLER

Jules G. Kish

July 1972

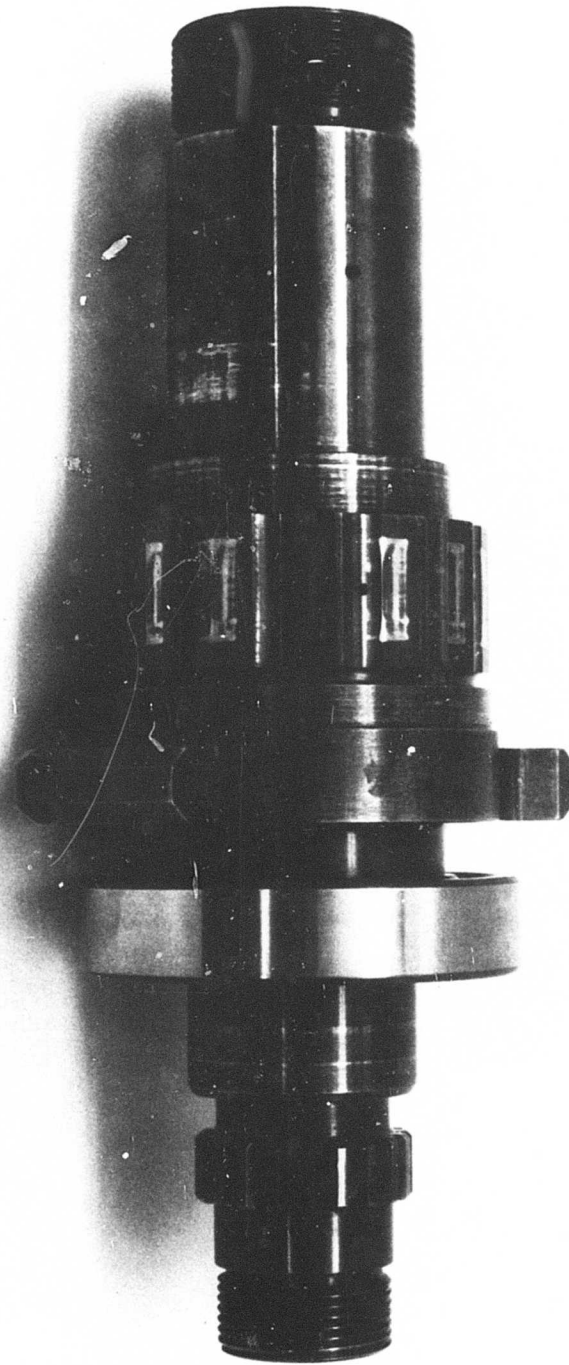
Figure 20. Cam at Completion of 50-Percent Differential-Speed Overrunning Test.

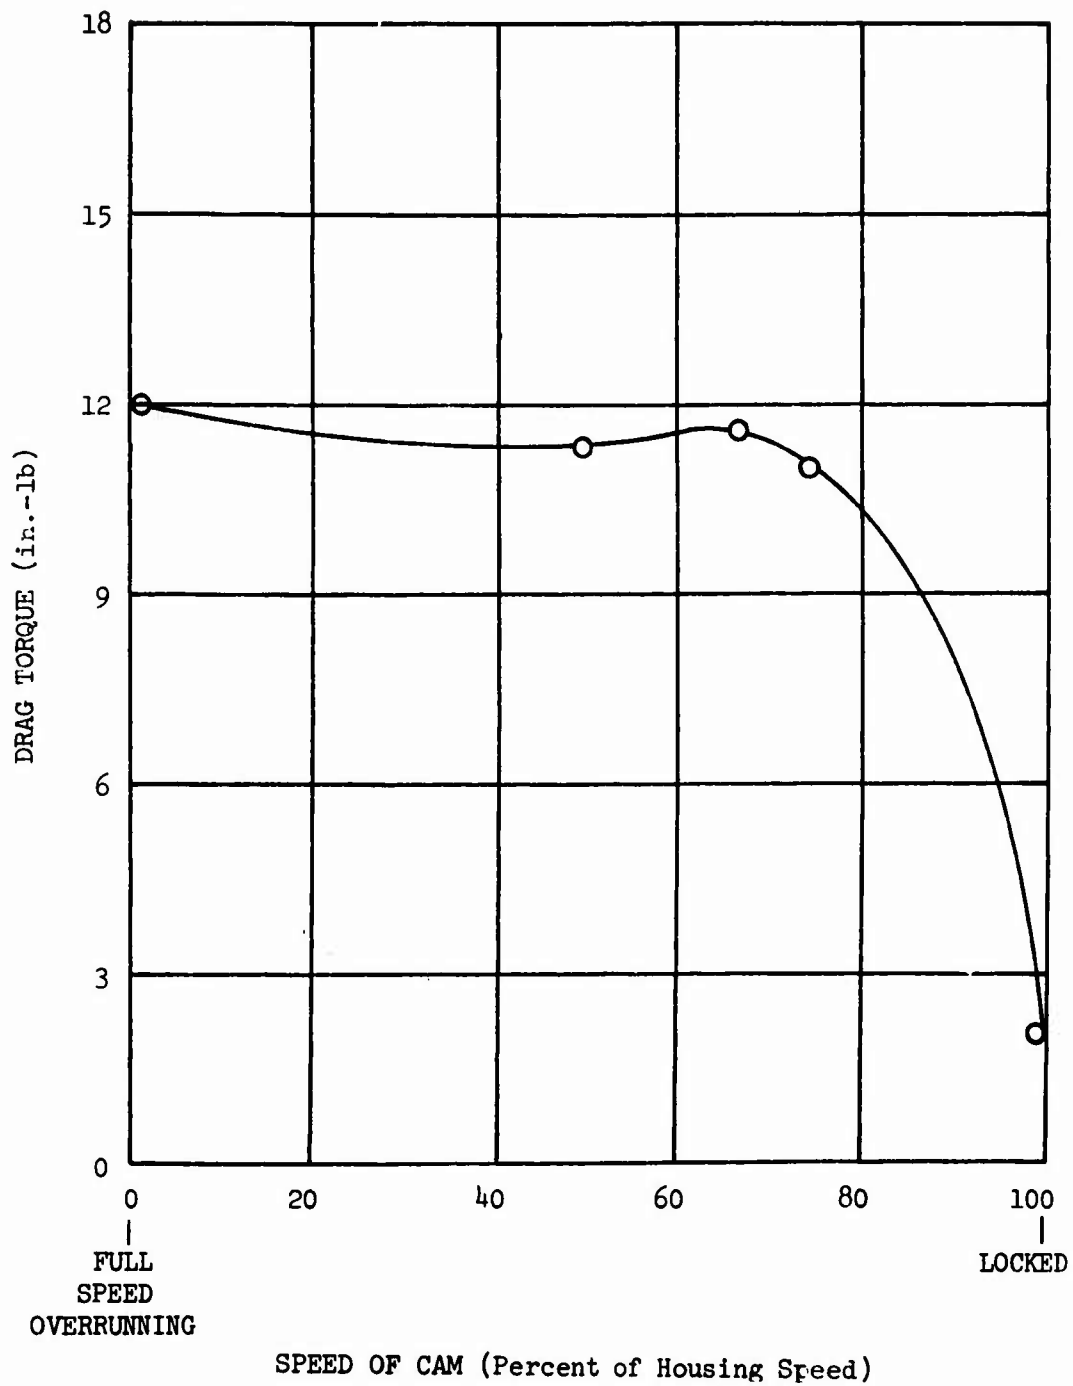
Figure 21. Drag Torque as a Function of Overrunning Speed at 1.8 gpm Flow.

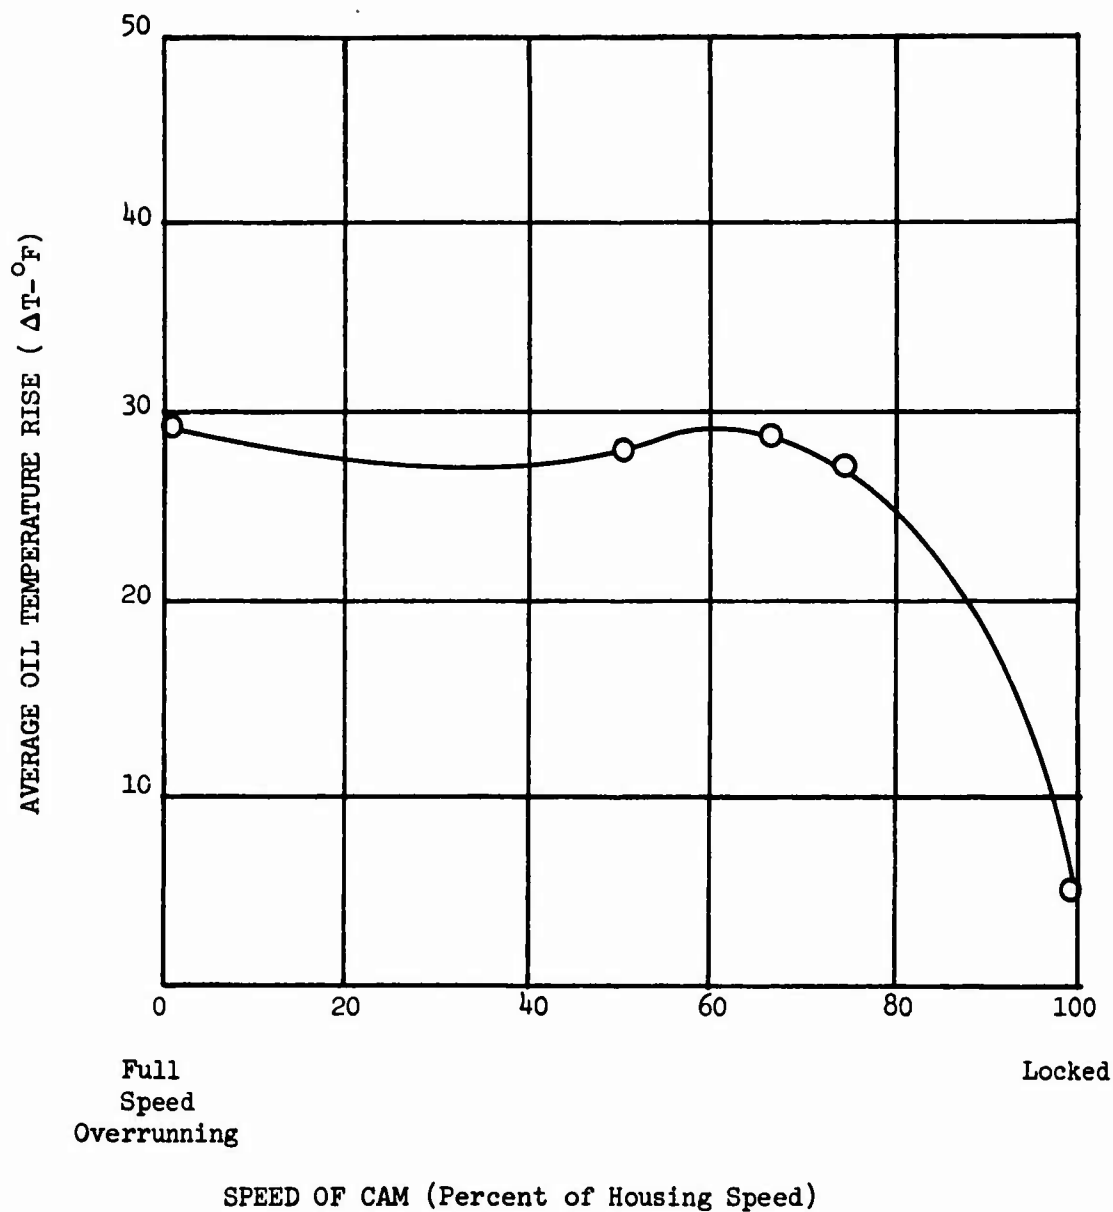
Figure 22. Variation of Oil Temperature Rise, ΔT , as a Function of Overrunning Speed at 1.8 gpm Flow.

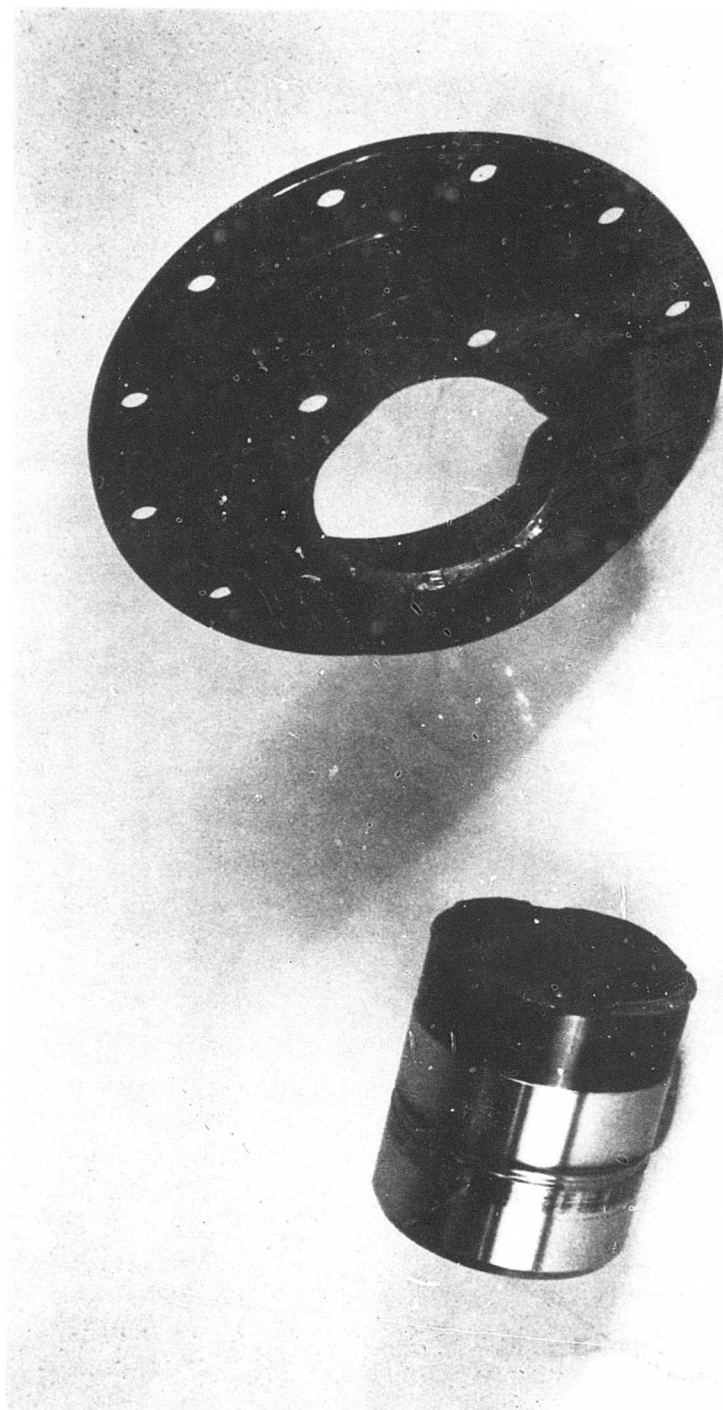
Figure 23. Adapter Flange Fracture, 100-Percent Speed Engagement Test.

Adapter flange fractures were caused by fatigue bending with multiple origins as discovered in post-test metallurgical evaluations. The adapter

flange failures were traced to a worn sleeve bearing in the H-3 gearbox facility. The sleeve bearing failure induced high bending stresses in the adapter shaft. The sleeve bearing is shown in Figure 26.

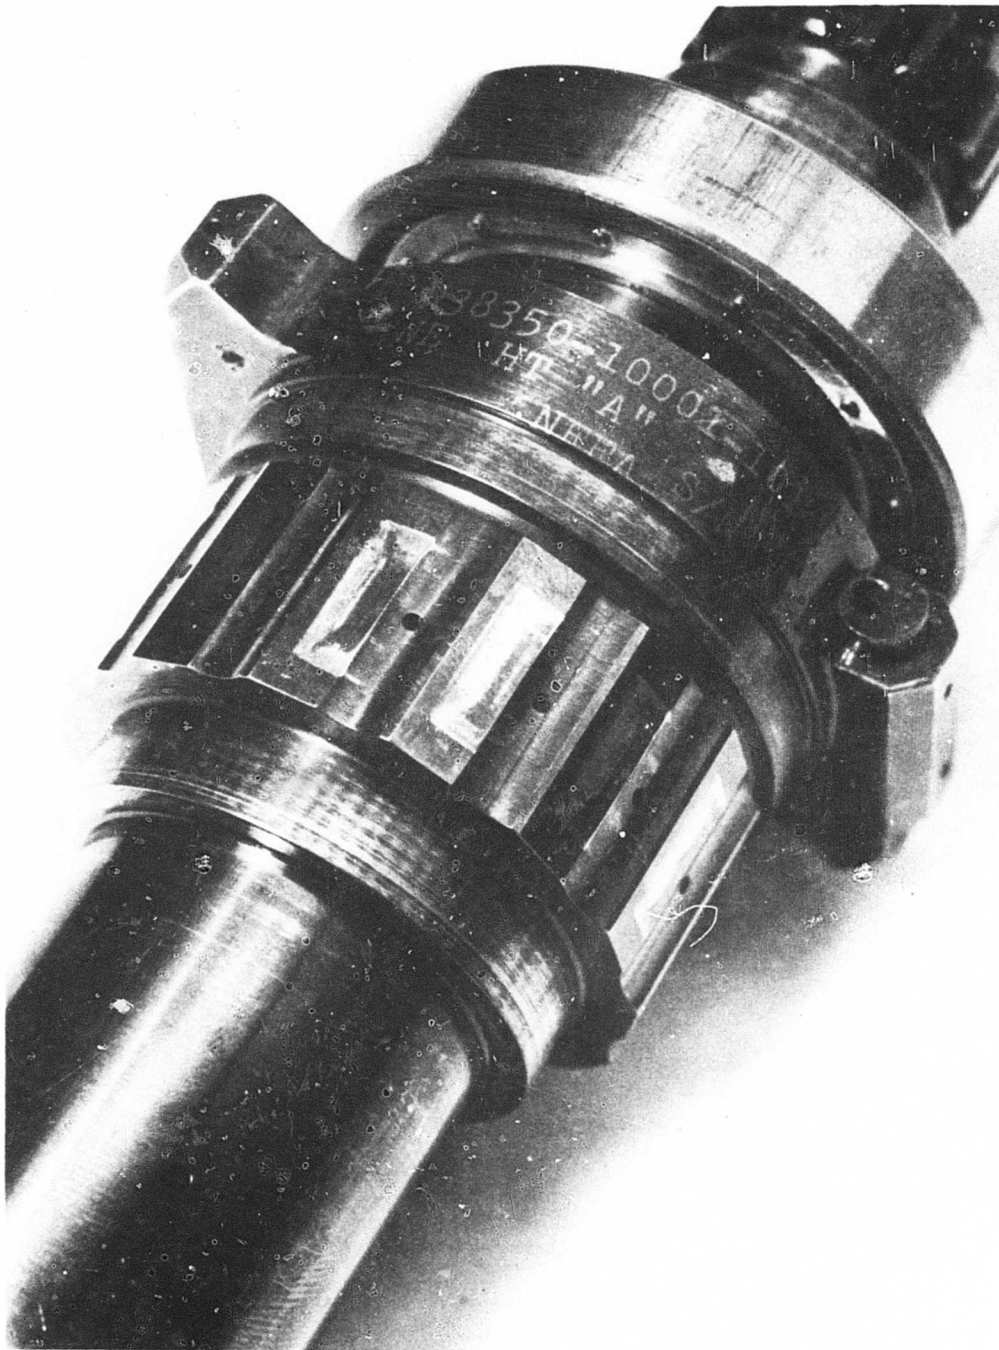
Figure 24. Cam Condition After Delayed Engagement.

The clutch was disassembled and inspected after the delayed engagement. The cam is shown in Figure 24. Indentations were found on all flats at approximately the center of the flat where the roller had jammed into the cam. These indentations measured 0.0018 inch maximum in depth. The rollers were brinnelled, with changes in original diameter ranging from 0.0013 to 0.0014 inch. The new adapter shaft failed in the same location as on the previous engagement tests. The cam, housing, rollers, and flange are shown in Figure 25.

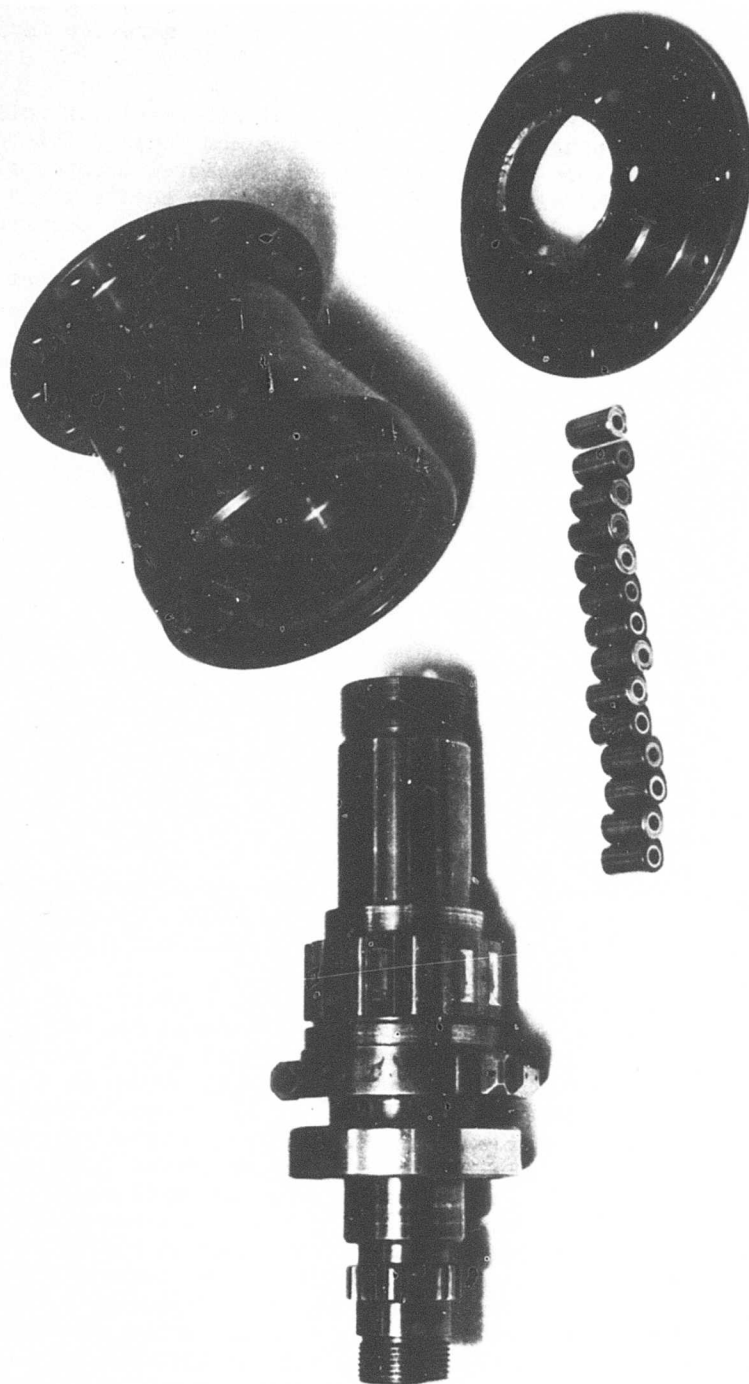
Figure 25. Clutch Components After Delayed Engagement.

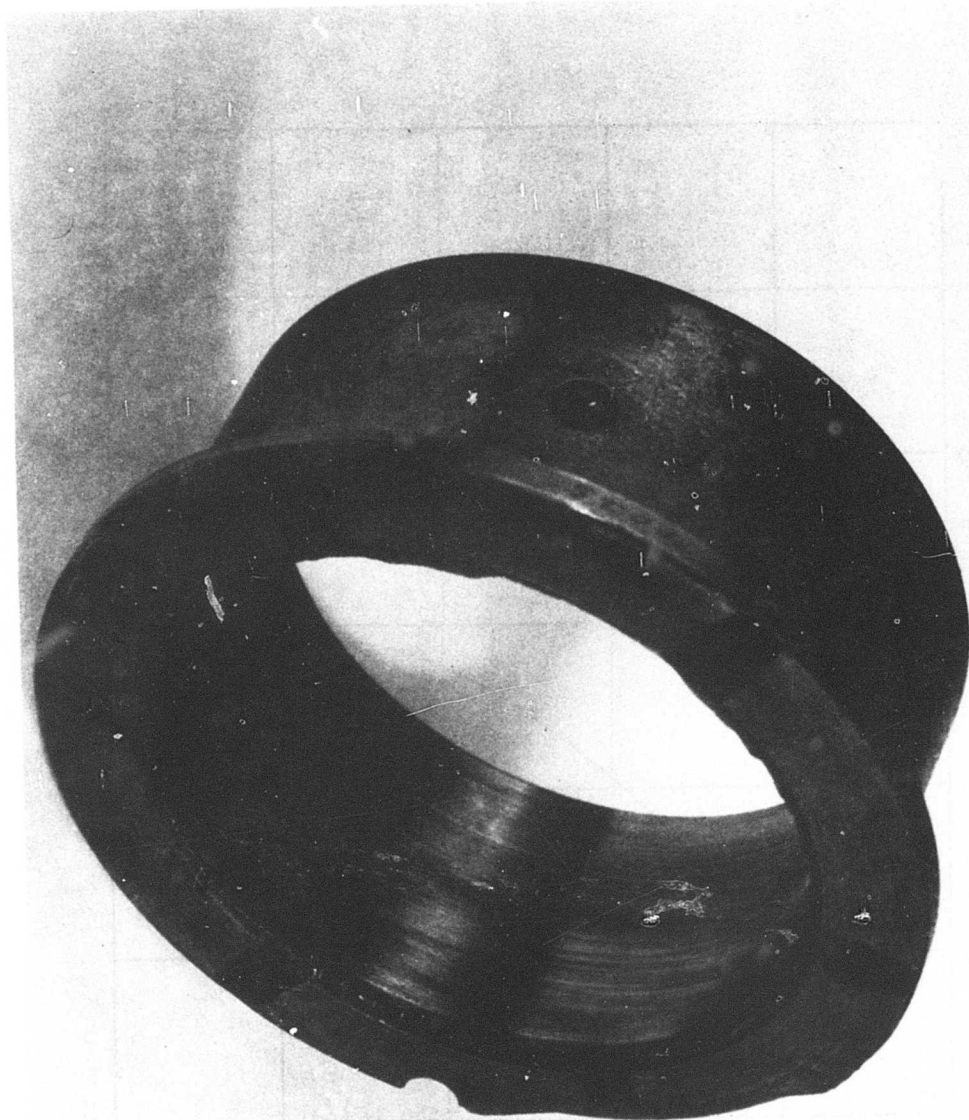
Figure 26. Sleeve Bearing at Completion of Dynamic Engagement Test.

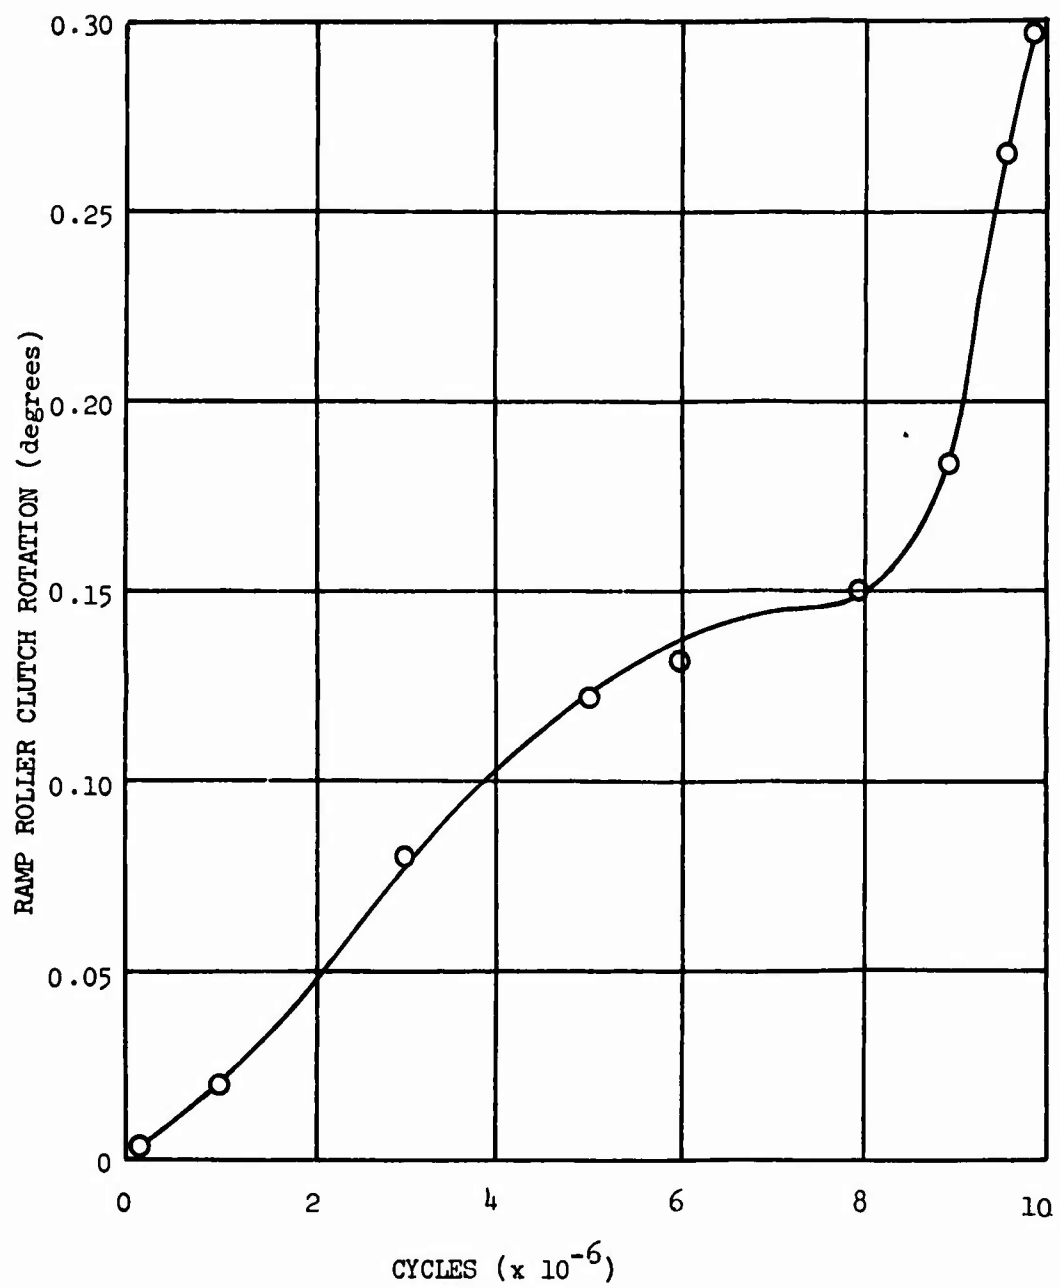
Figure 27. Clutch Creep Under the Influence of Cyclic Loading.

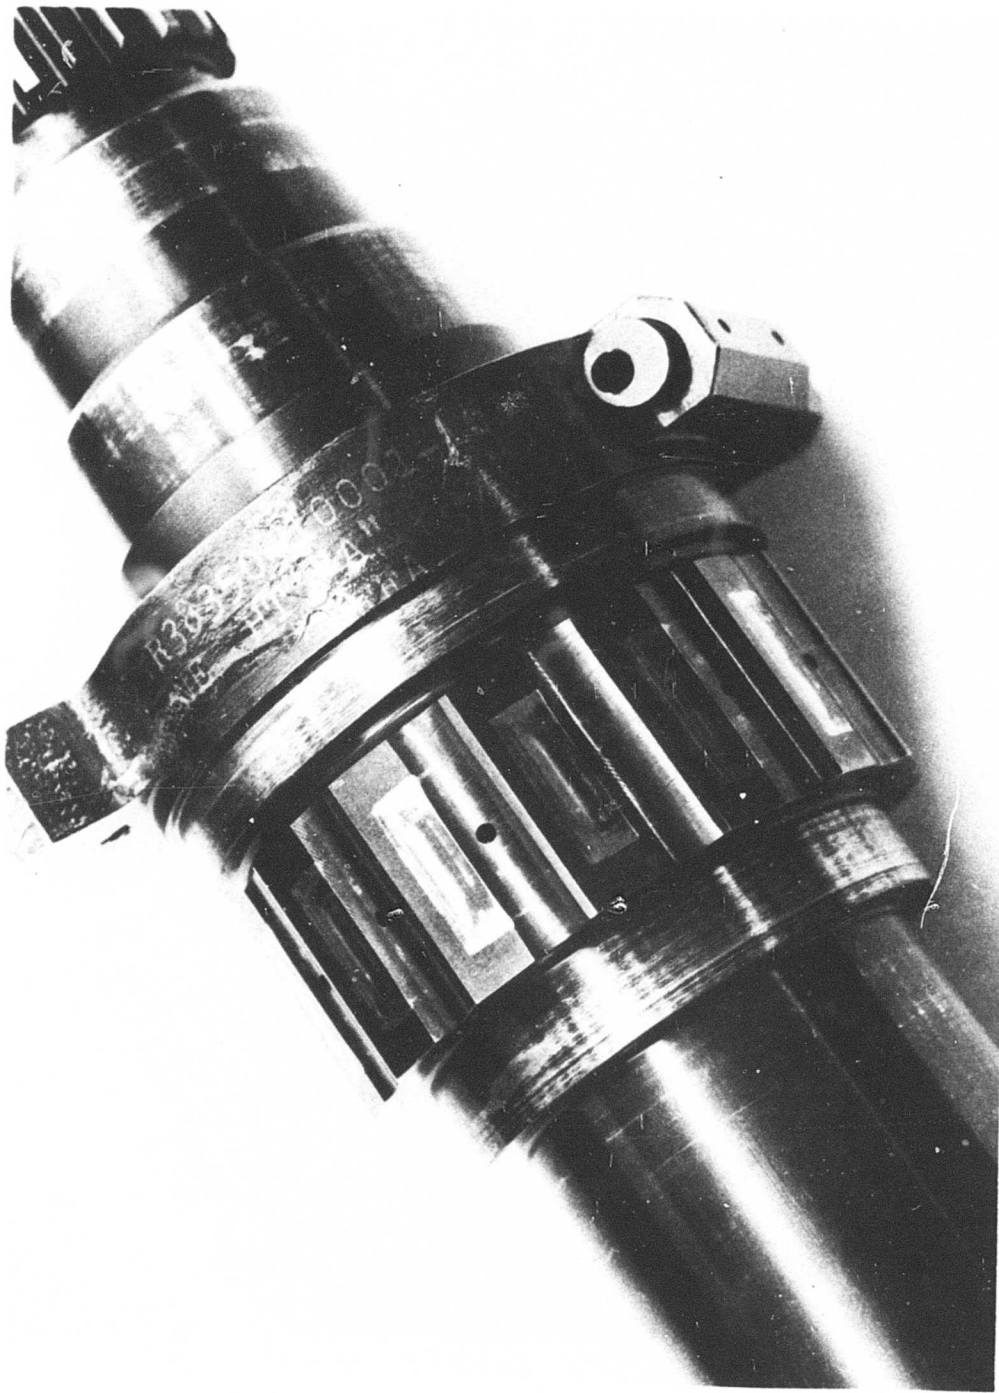
Figure 28. Clutch Cam After Static Cyclic Test.

Disassembly inspection of the cam after the 10 million cycle test revealed slight fretting of the cage oilite bushing on the bushing journal as shown in Figure 28. Three of fourteen cam flats had brinnell marks measuring 0.0004, 0.0003, and 0.0003 inch in depth. The housing, shown in Figure 29, experienced heavy chafing and wear of the contacting surface between rollers and housing. The tungsten-carbide flame coating was damaged to a depth of 0.005 inch, which was through the coating to the carburized surface beneath. The rollers had slight spalling on the side in contact with the cam and heavy spalling on the side in contact with the housing, although compressive stresses are lower on the housing side due to the housing radius of curvature (concave/convex contact on housing and flat/convex contact on cam). One roller of the fourteen was fractured as shown in Figure 30. The roller was fractured by fatigue stresses with origins on the outer surfaces. Therefore, it was assumed that stress concentrations introduced by breakdown of the tungsten-carbide coating on the contacting roller surfaces caused the roller failure. The maximum roller stress is at the inside on

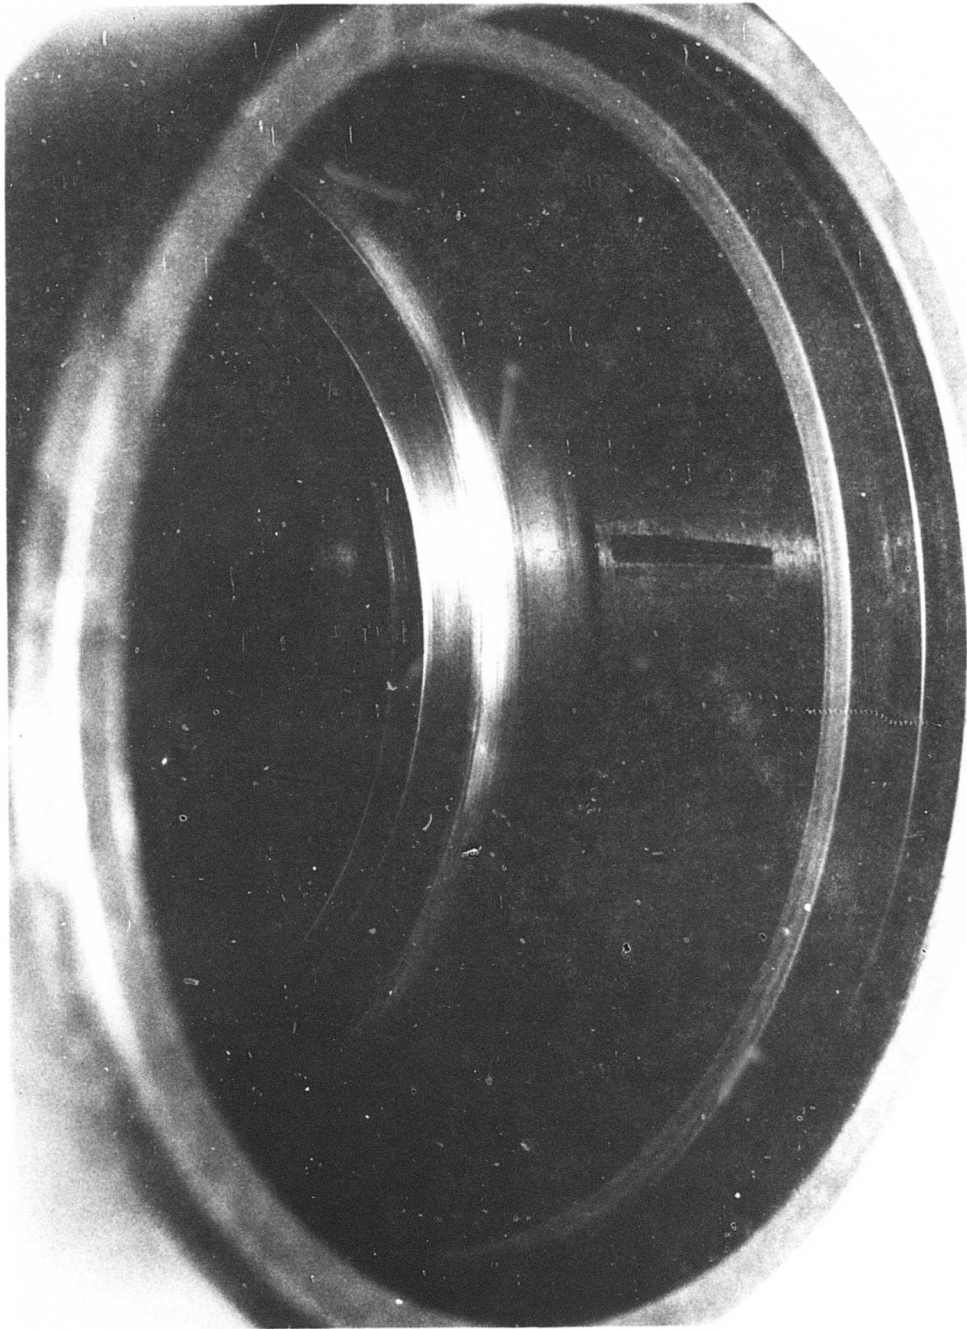
Figure 29. Outer Housing Wear Pattern in Tungsten-Carbide
Flame Plating, Static Cyclic Test.

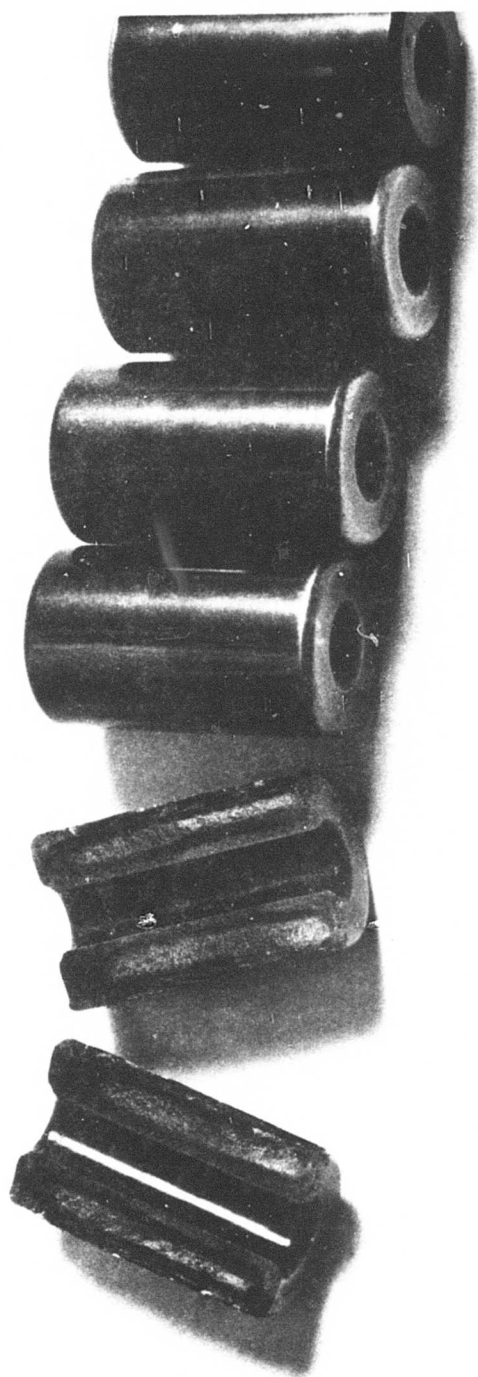
Figure 30. Roller Fatigue Fracture, Static Cyclic Test.

the surface of the hole under the load as shown in Appendix II. The calculated roller stresses at the test load were $250,000 \pm 35,000$ psi. These stresses are below the endurance limit for the roller material.

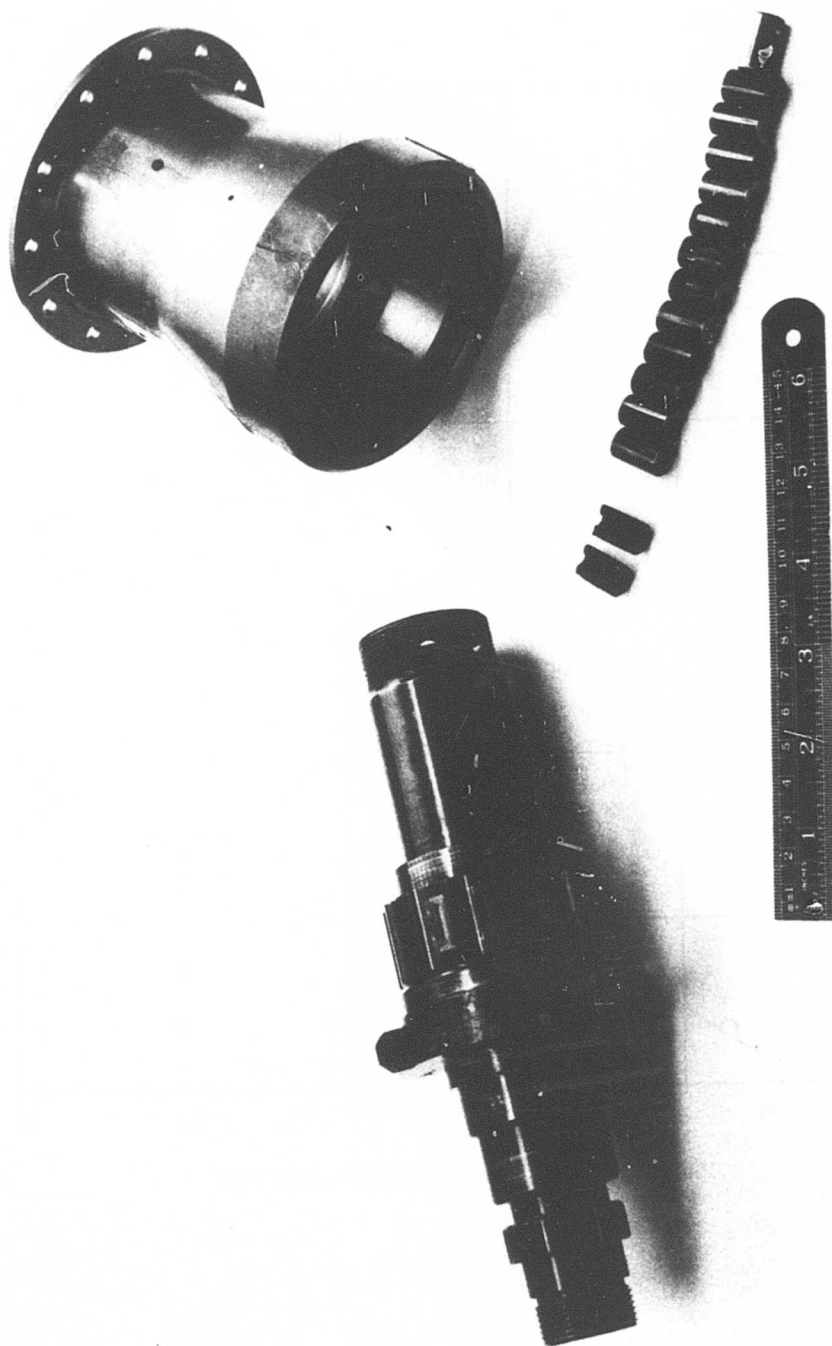
Figure 31. Clutch Components After Static Cyclic Test.

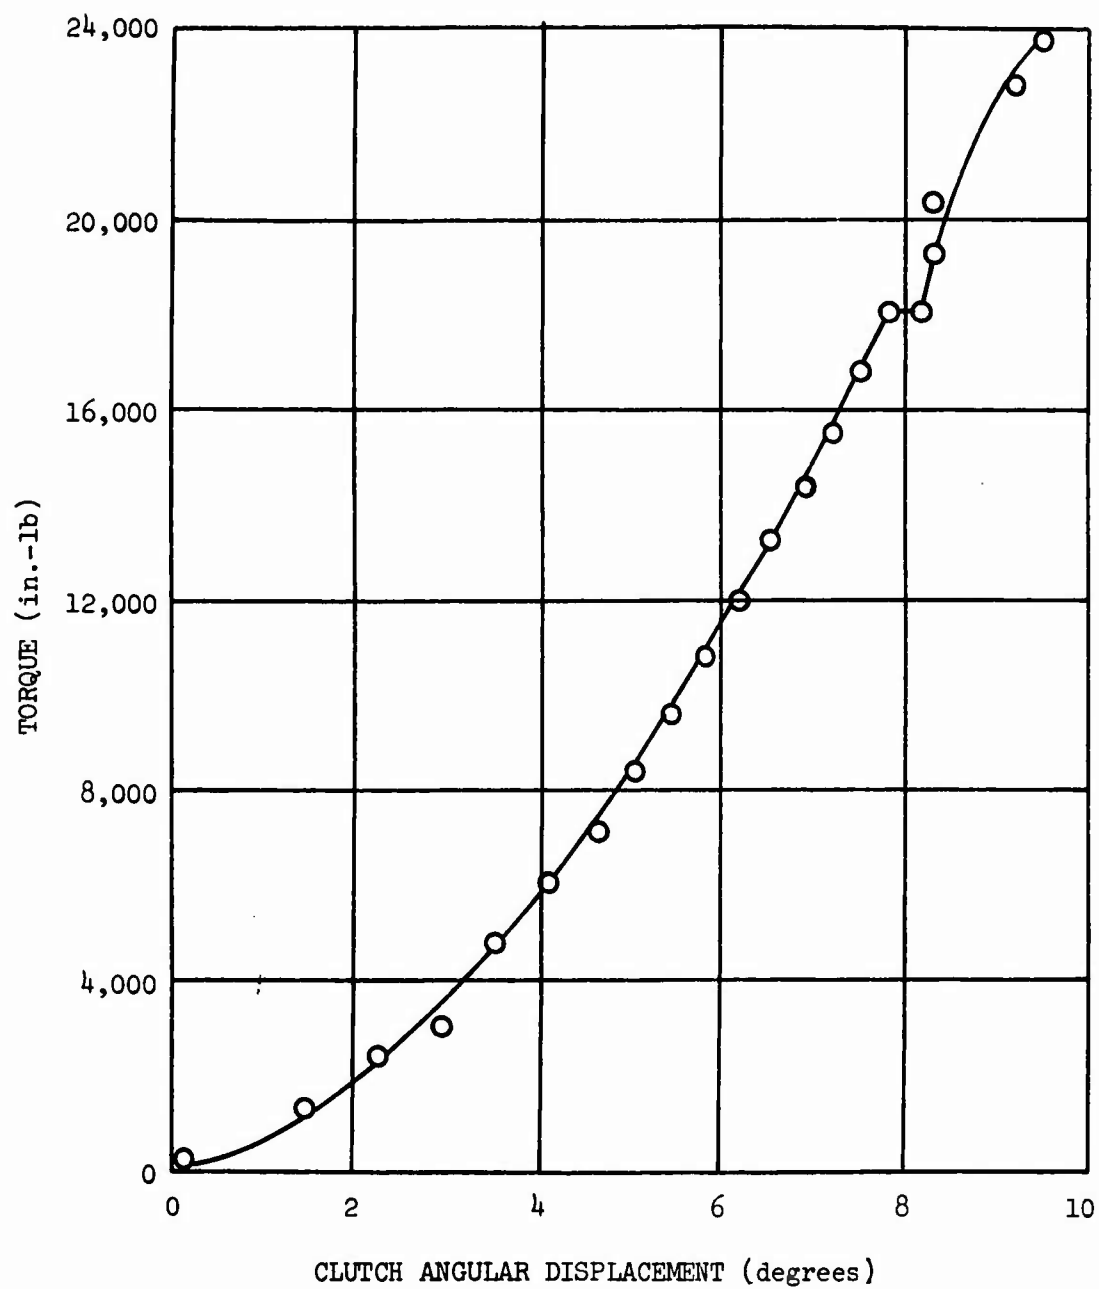
Figure 32. Ramp Roller Clutch Torsional Spring Rate.

Torsional spring rate, or clutch angular deflection versus torque, is shown in Figure 32 for the flame-plated housing. Identical results were obtained with the carburized housing.

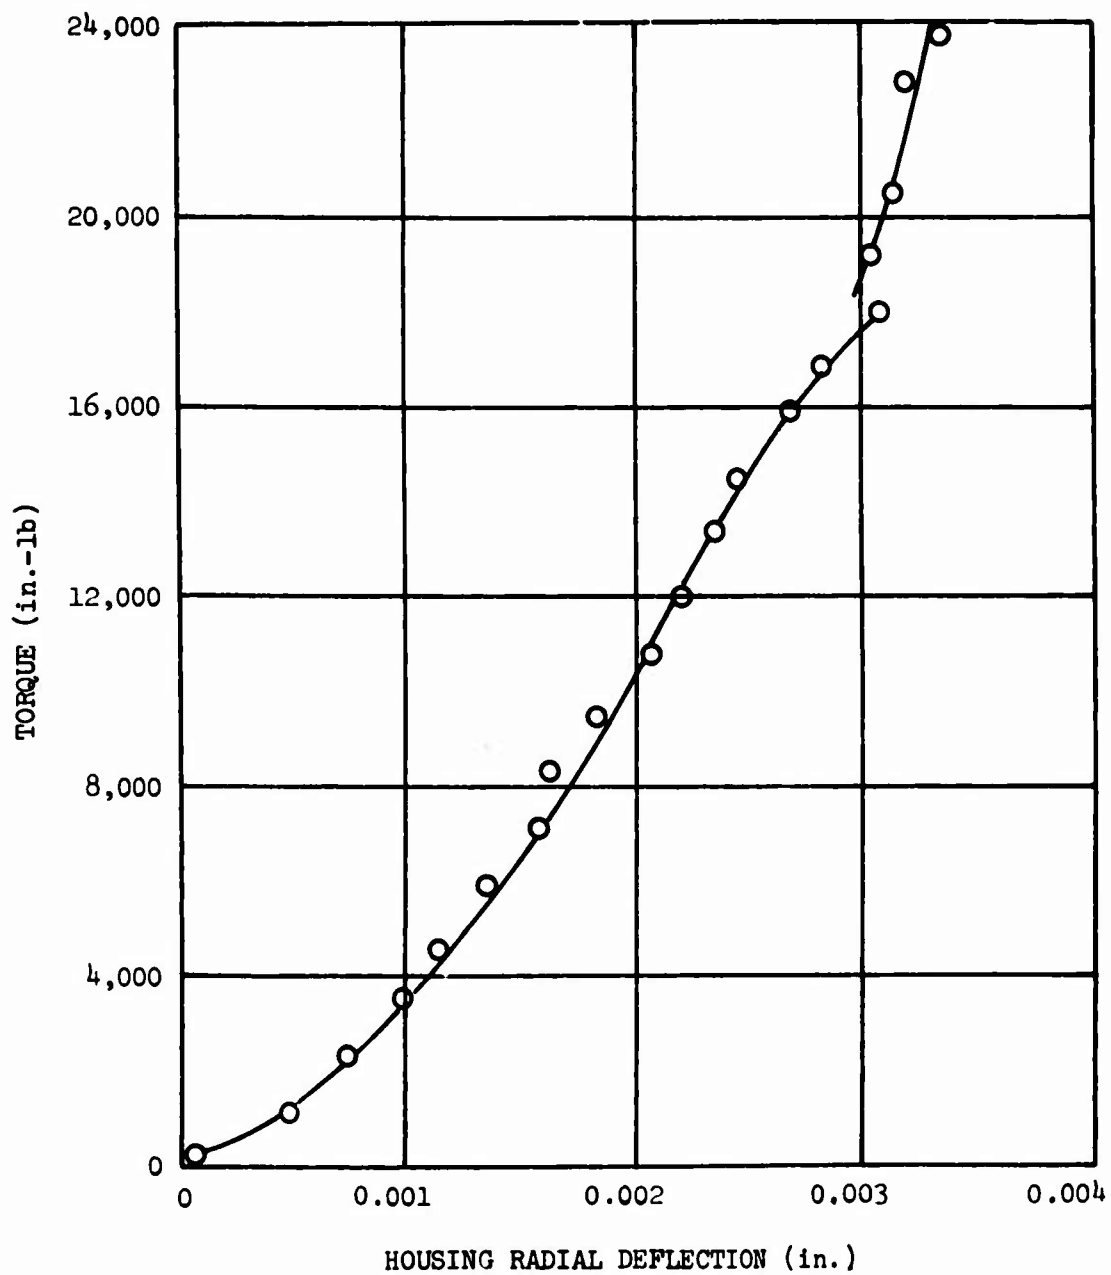
Figure 33. Ramp Roller Clutch Outer Housing Radial Spring Rate.

Outer housing radial deflection was recorded for both tests as a function of clutch torque and is shown in Figure 33. Note the yielding at 18,000 inch-pounds torque, indicating roller cracking.

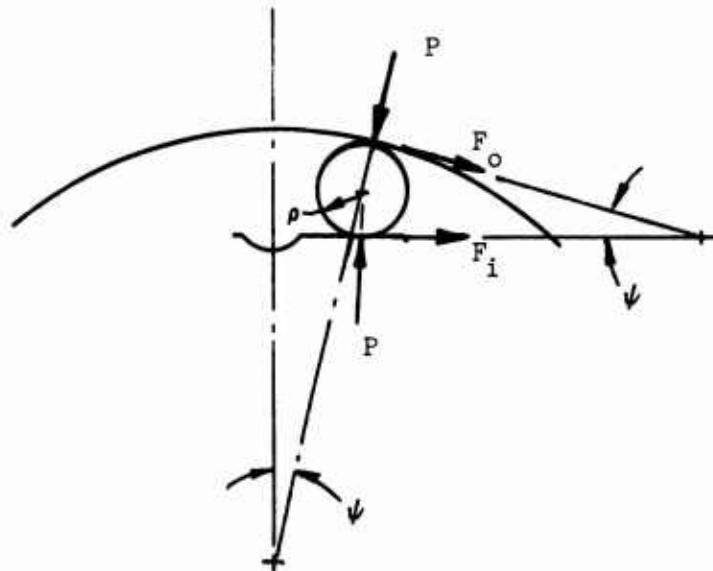
Figure 34. Loads Imposed on Roller.

Figure 34 shows the loads imposed on the roller.

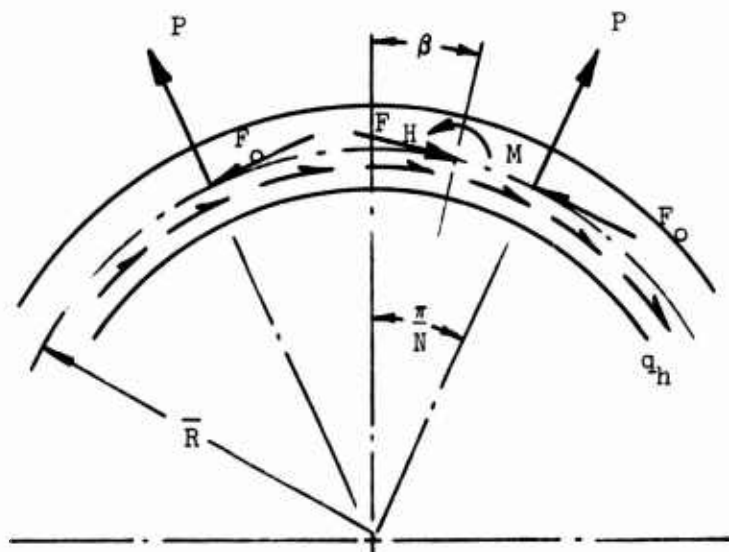
Figure 35. Roller Contact Loads on Outer Housing.

The ramp roller clutch housing is subjected to bending and tensile stresses induced by roller loads. The housing is analyzed as a ring subjected to 14 equally spaced loads reacted at the output flange as a uniform shear flow. A typical load point is shown in Figure 35.

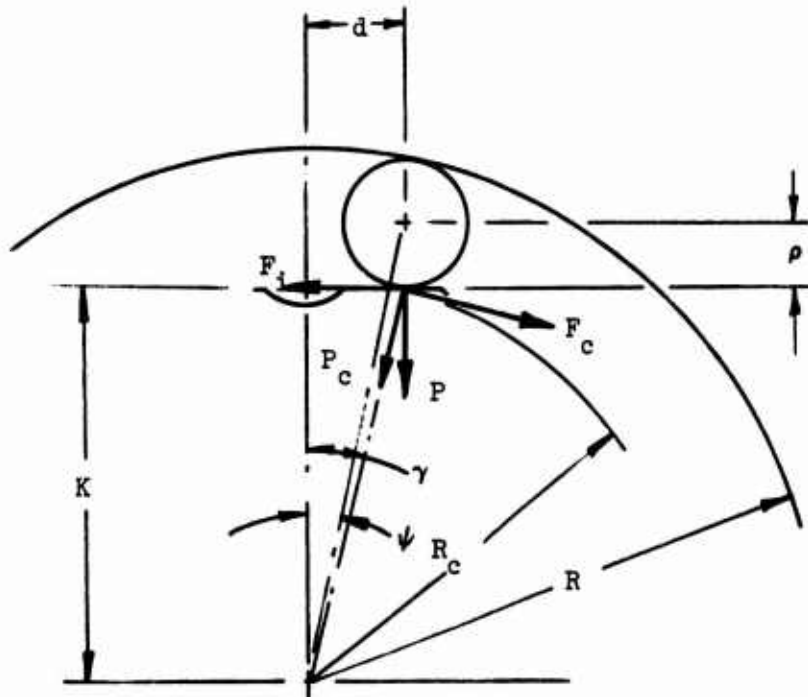
Figure 36. Roller Contact Loads on Inner Cam.

The ramp roller clutch camshaft is analyzed in a manner similar to the outer housing but with loading inward instead of outward as shown in Figure 36. Ring formulas are used with 14 equally spaced loads and uniform shear flow acting at the radius to the centroid R_r of the input torque flange.

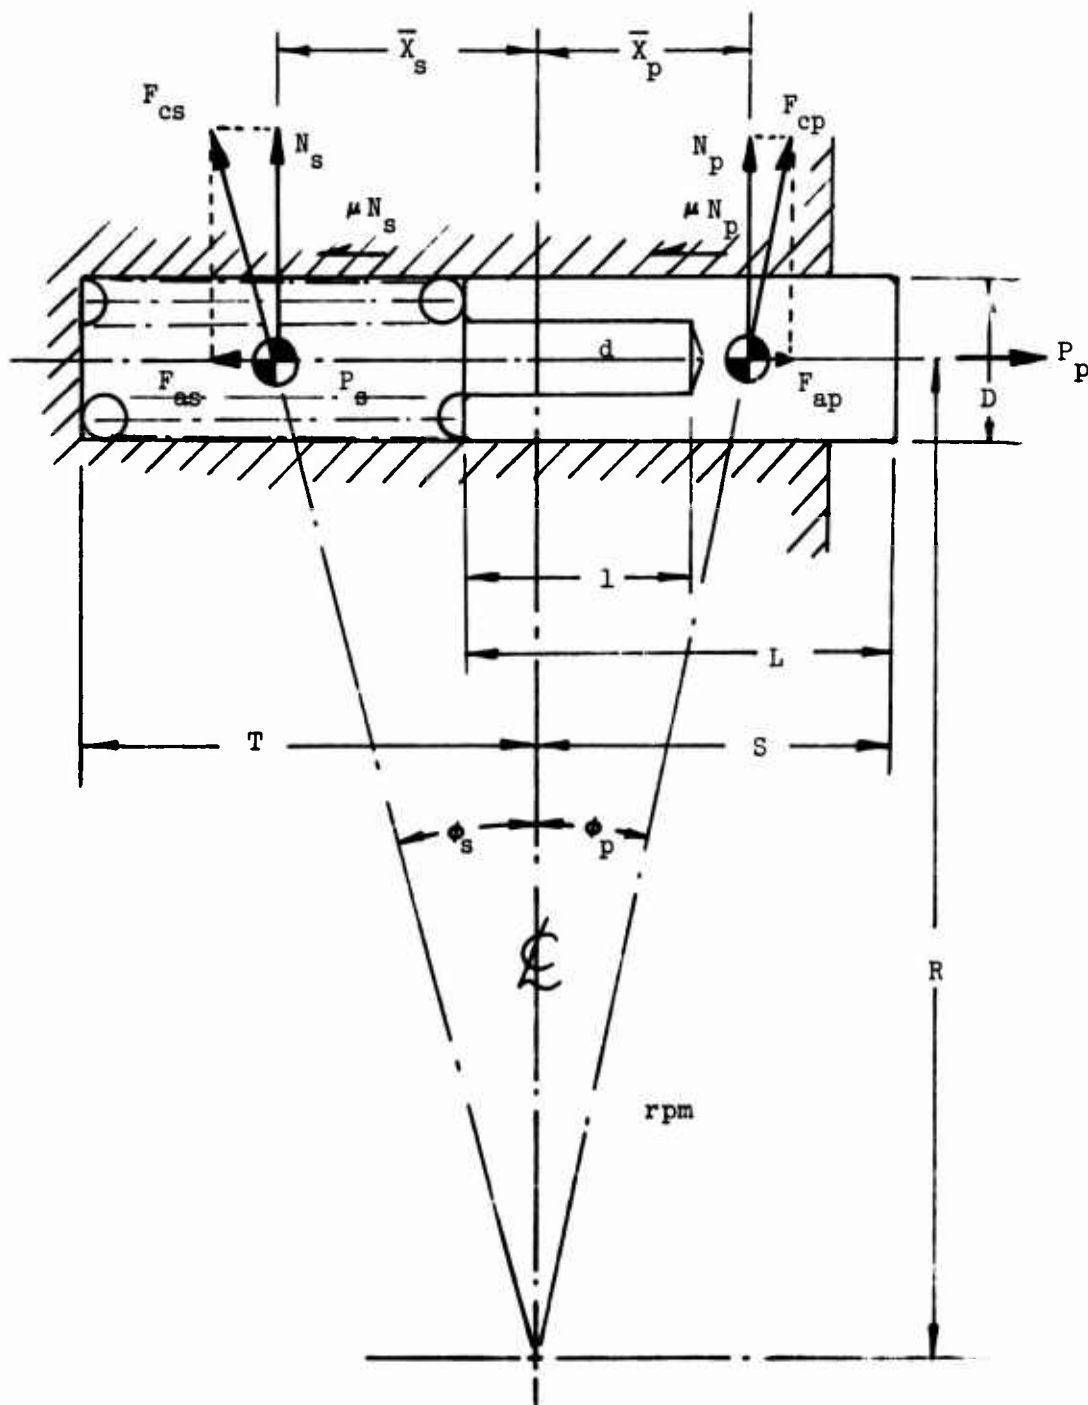
Figure 37. Roller Retainer Return-Pin-Spring Assembly Geometry and Dynamic Forces.

The pin and spring assembly as shown in Figure 37, exerts a force on the roller retention cage which causes the rollers to contact the outer housing and ramp roller cam at all times. Improper design can cause the torque on the roller retention cage to reverse under dynamic conditions due to centrifugal forces. This phenomenon is critical when the cam and rollers are in the freewheel position, i.e., initial contact angle. P_p as shown in Figure 37, is the total force on the roller retention cage due to static and dynamic forces. In the ideal design, P_p should remain constant under all conditions of rpm.

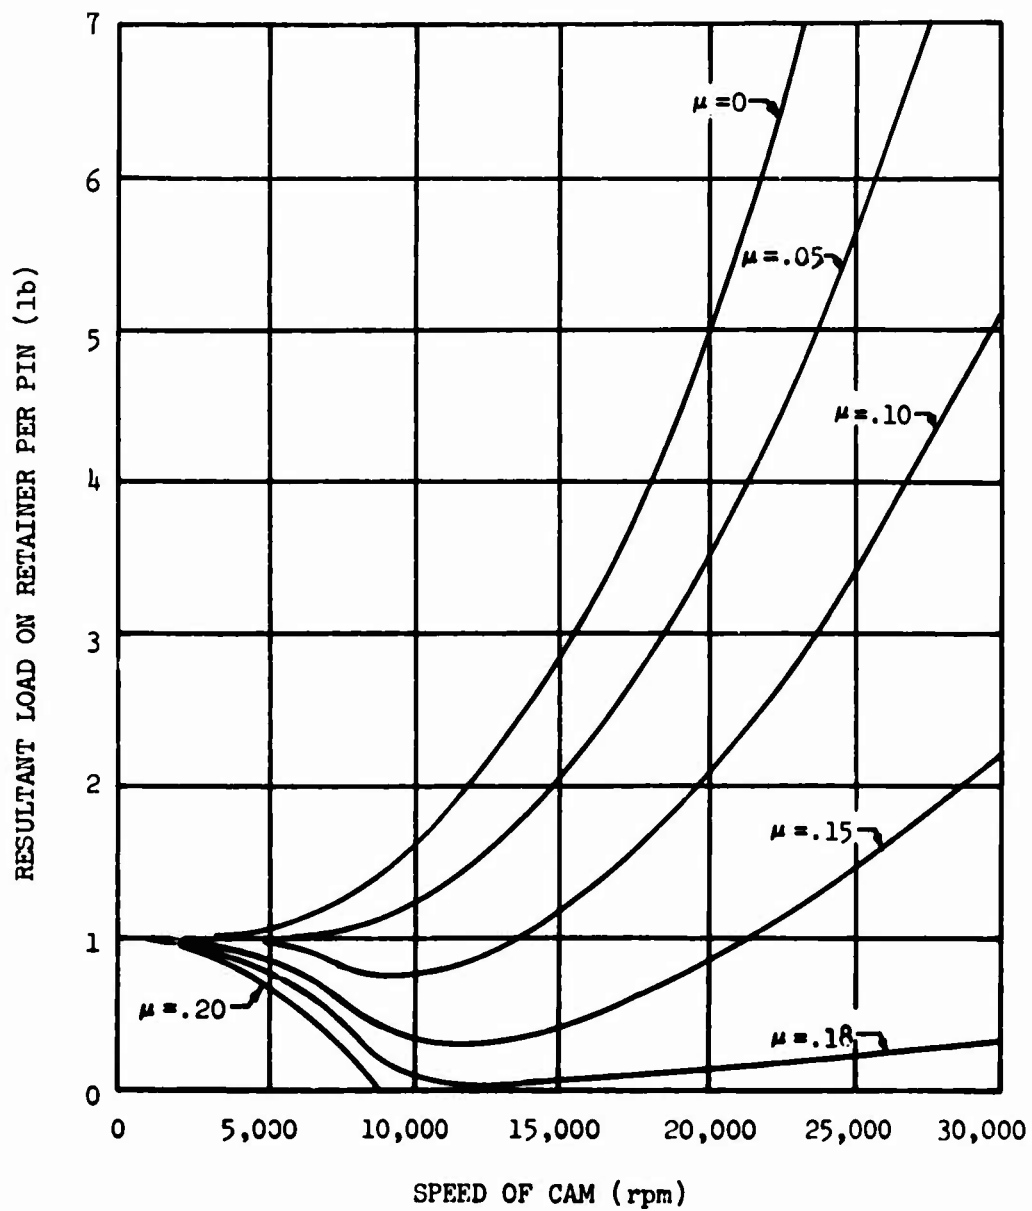
Figure 38. Resultant Pin Load on Retainer for Various Values of Coefficient of Friction.

Examination of Equation (48) reveals that $P_p = 0$ when the coefficient of friction μ is greater than .18 and the rpm is such that $P_s = 0$. Figure 38 is a plot of resultant pin load versus rpm for various values of coefficient of friction. It shows that for a range of practical values of μ , the resultant pin load is always positive.
